FINAL REPORT
APRIL 1990

REPORT NO. EVT 17-90

COMPARISON OF STANDARD
ISSUE AND ANCRA
INTERNATIONAL MILVAN
RESTRAINT BEAMS IN STATIC
AND DYNAMIC ENVIRONMENTS

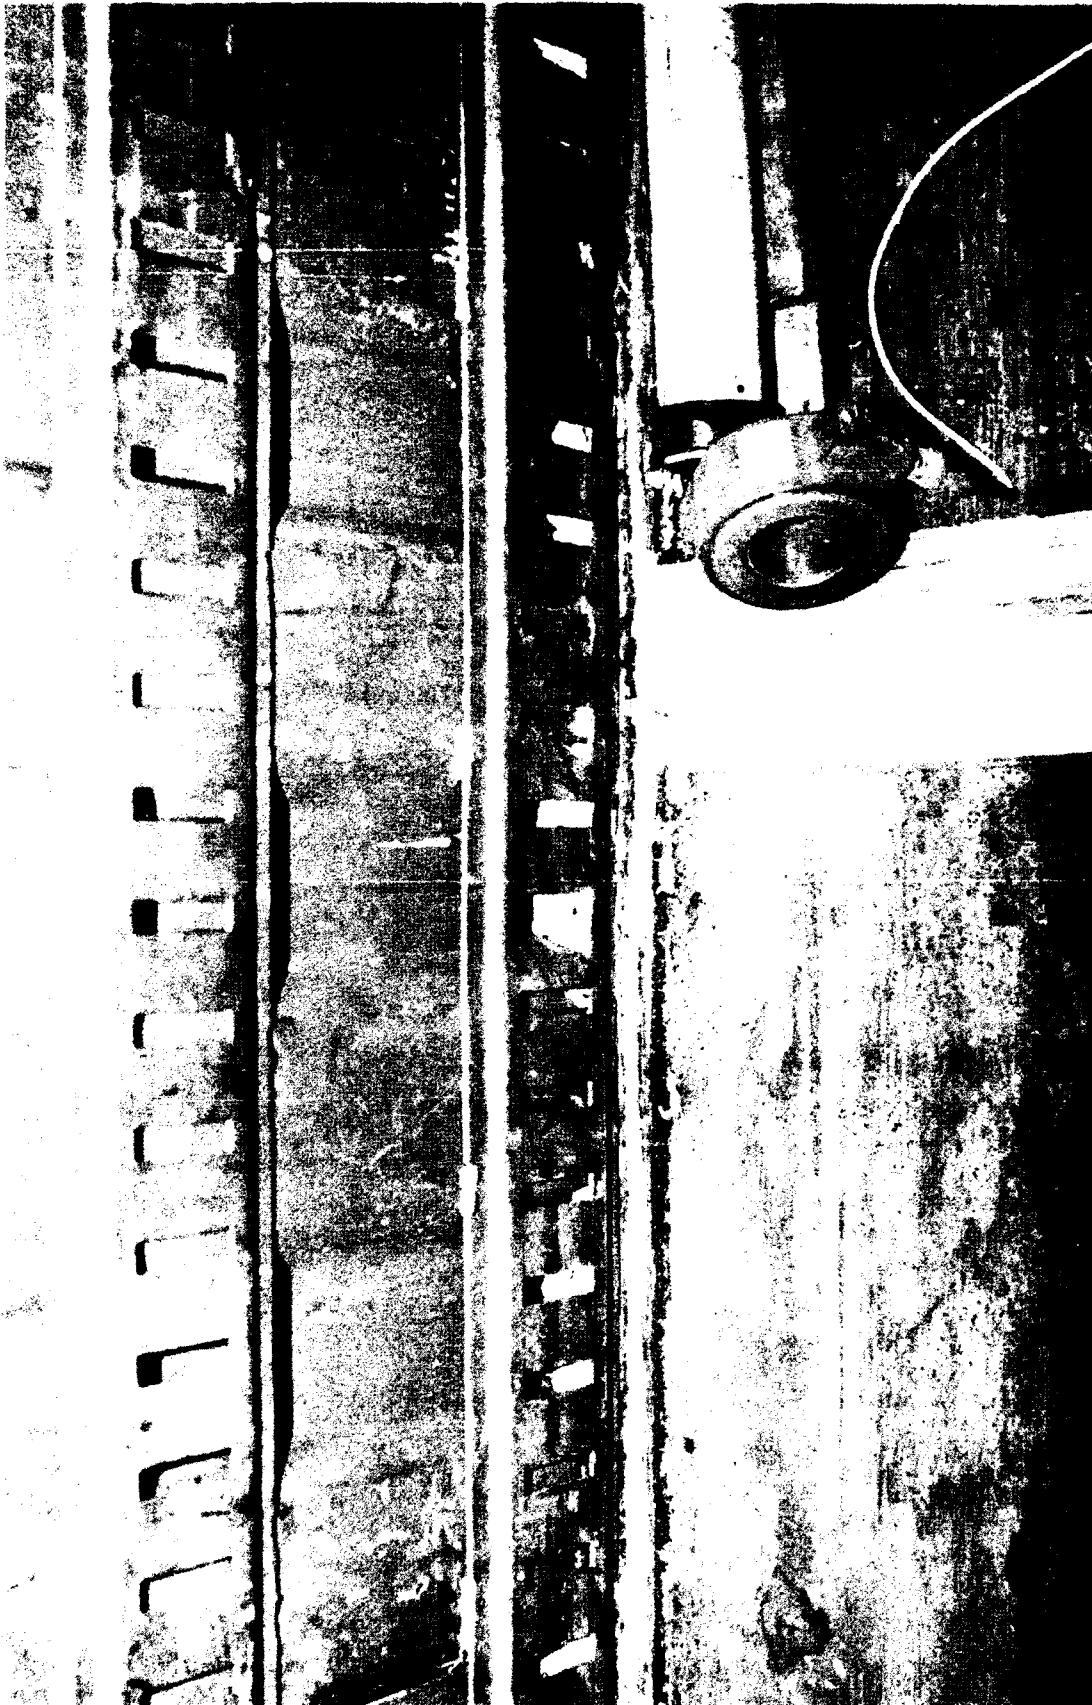
U.S. ARMY DEFENSE AMMUNITION CENTER AND SCHOOL - SAVANNA, IL	Photo No. A0317-SPN-90-229-3023. This photo shows the original issue restraint beam, sample no. 2, after end loading. Note deformation of the latch mechanism.
--	--

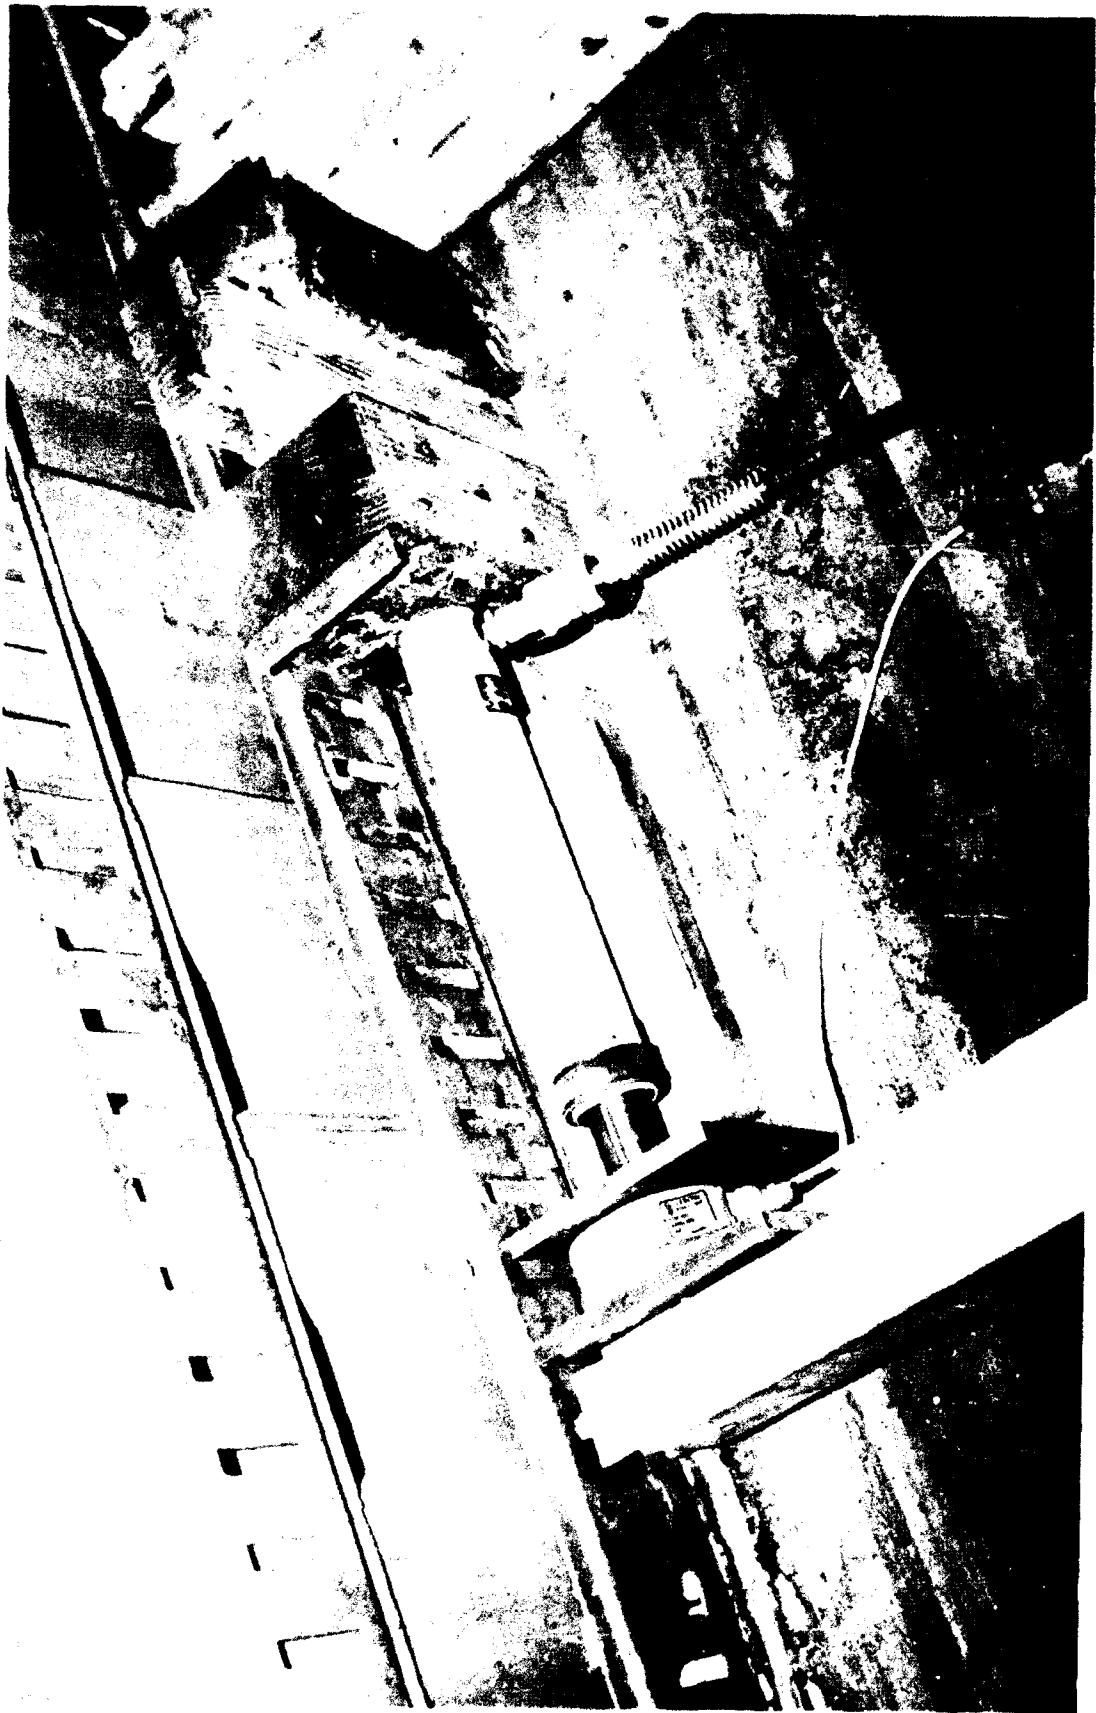
Photo No. A0317-SPN-90-229-3025. This photo shows the original issue restraint beam, sample no. 3, before end loading. The hydraulic cylinder was extended until belt rail failure.

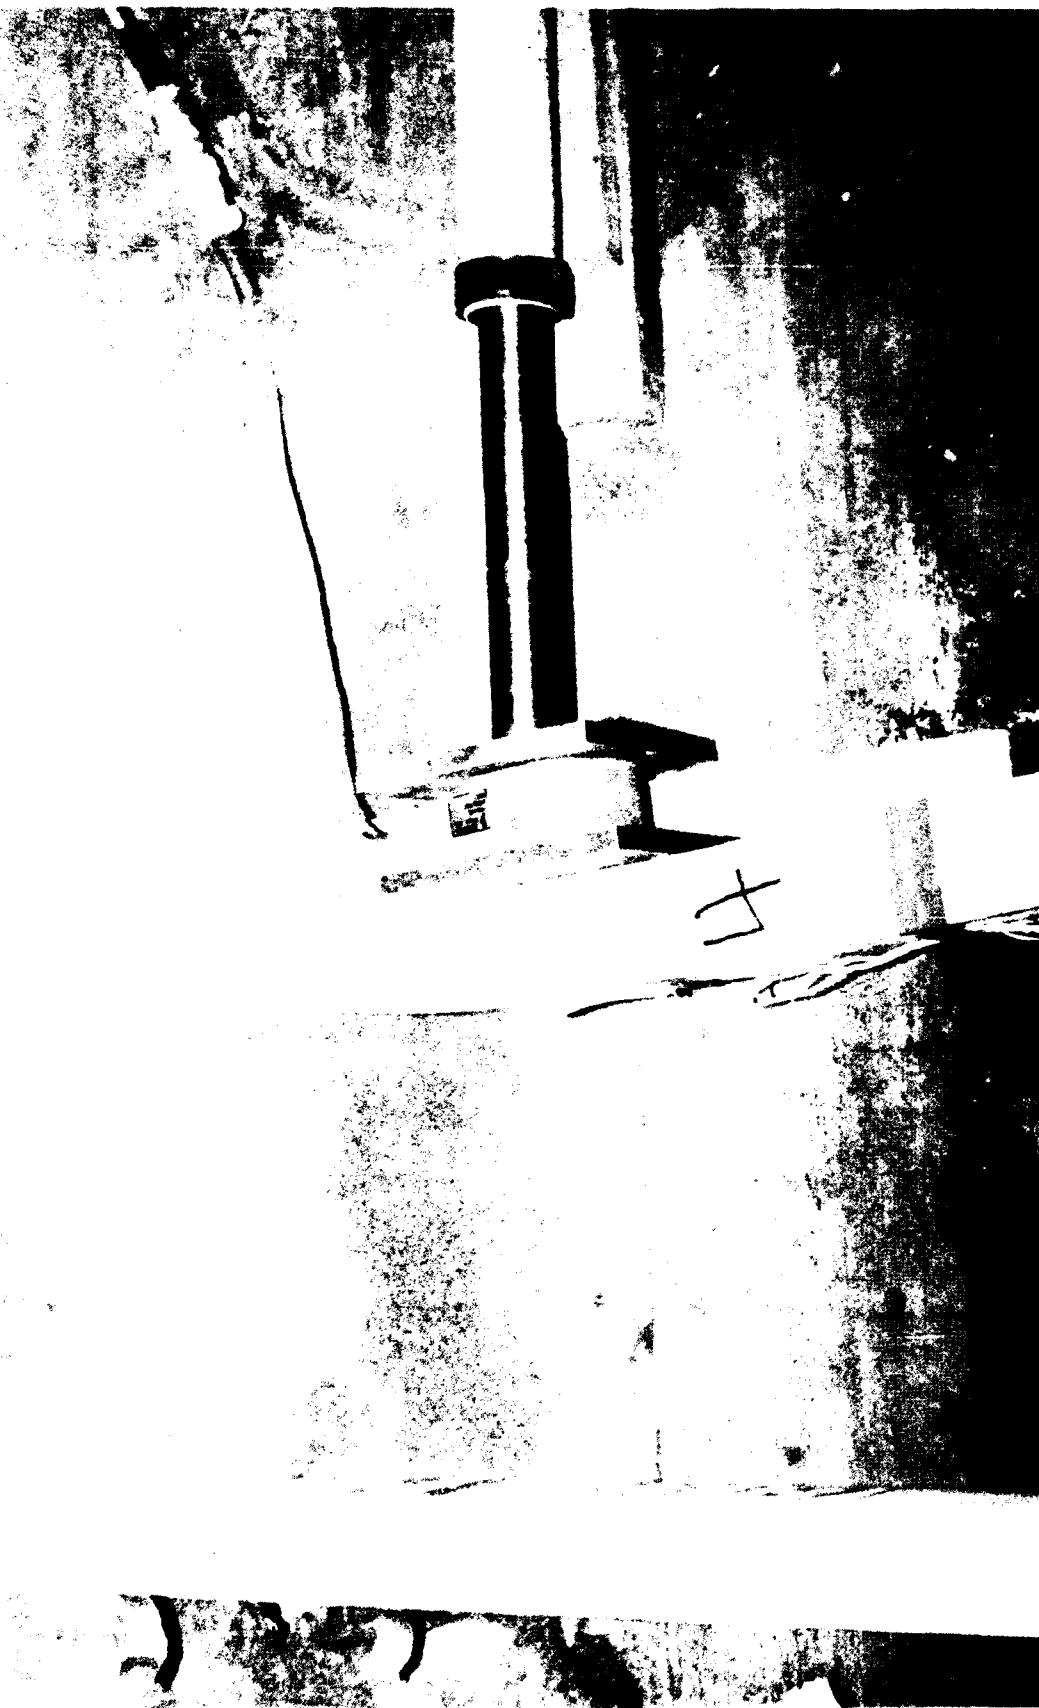
Photo No. A0317-SPN-90-229-3031. This photo shows the original issue restraint beam, sample no. 4, after point loading. The hydraulic cylinder was extended until permanent deformation of the restraint beam occurred.

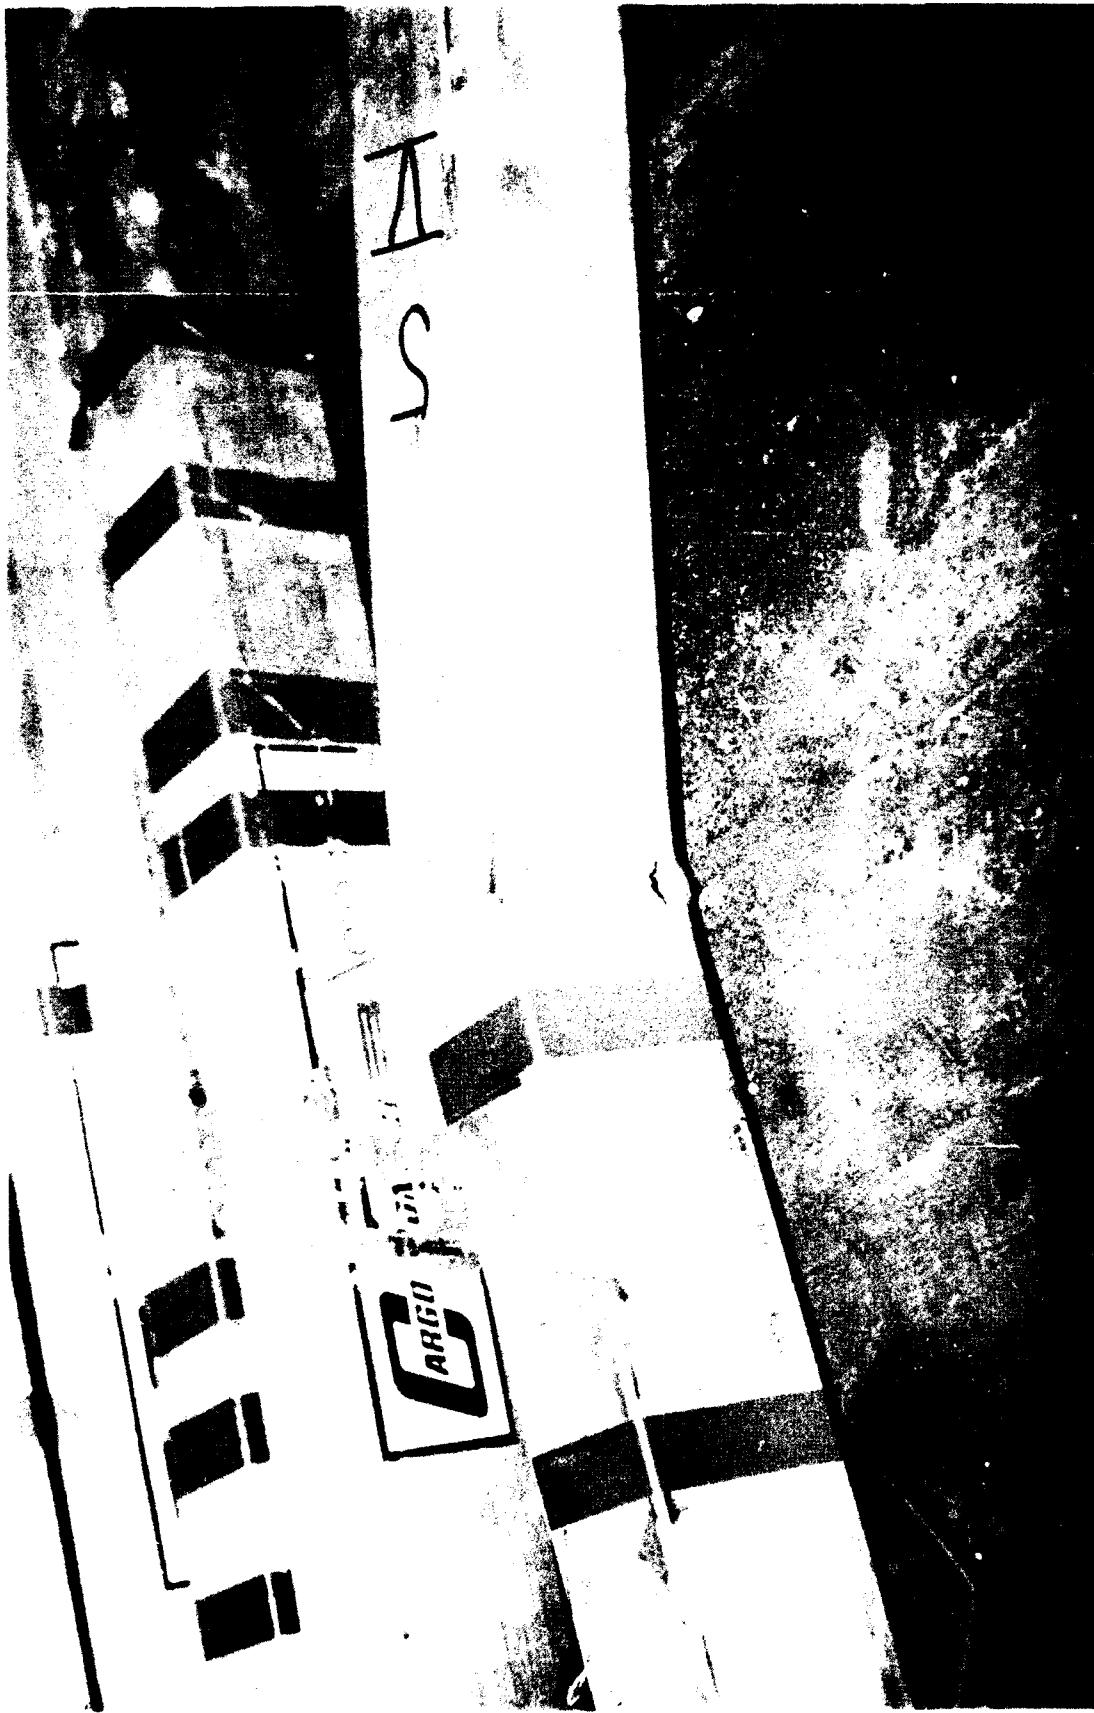
Photo No. A0317-SPN-90-229-3035. This photo shows the original issue restraint beam, sample no. 5, after point loading. This sample pulled out of the belt rail.

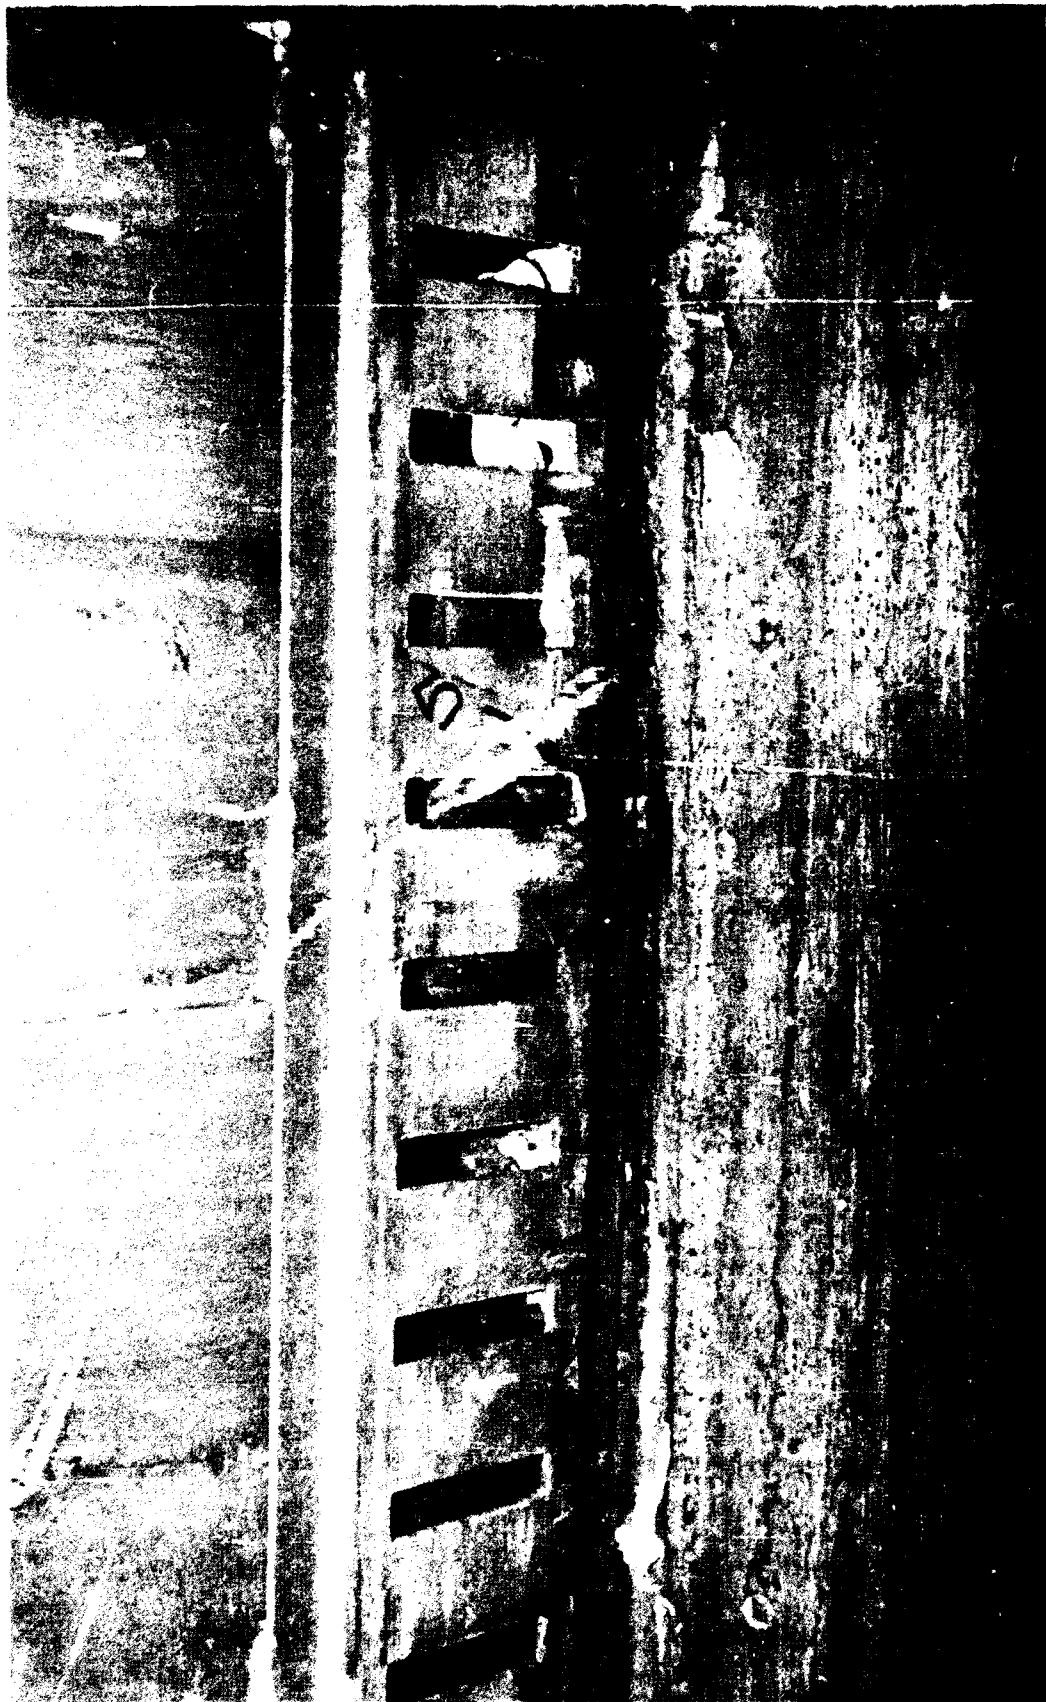
Photo No. A0317-SPN-90-229-3034. This photo is a closeup of the belt rail where sample no. 5 pulled out. Note damage to the lower part of the interlock from the restraint bar hook.

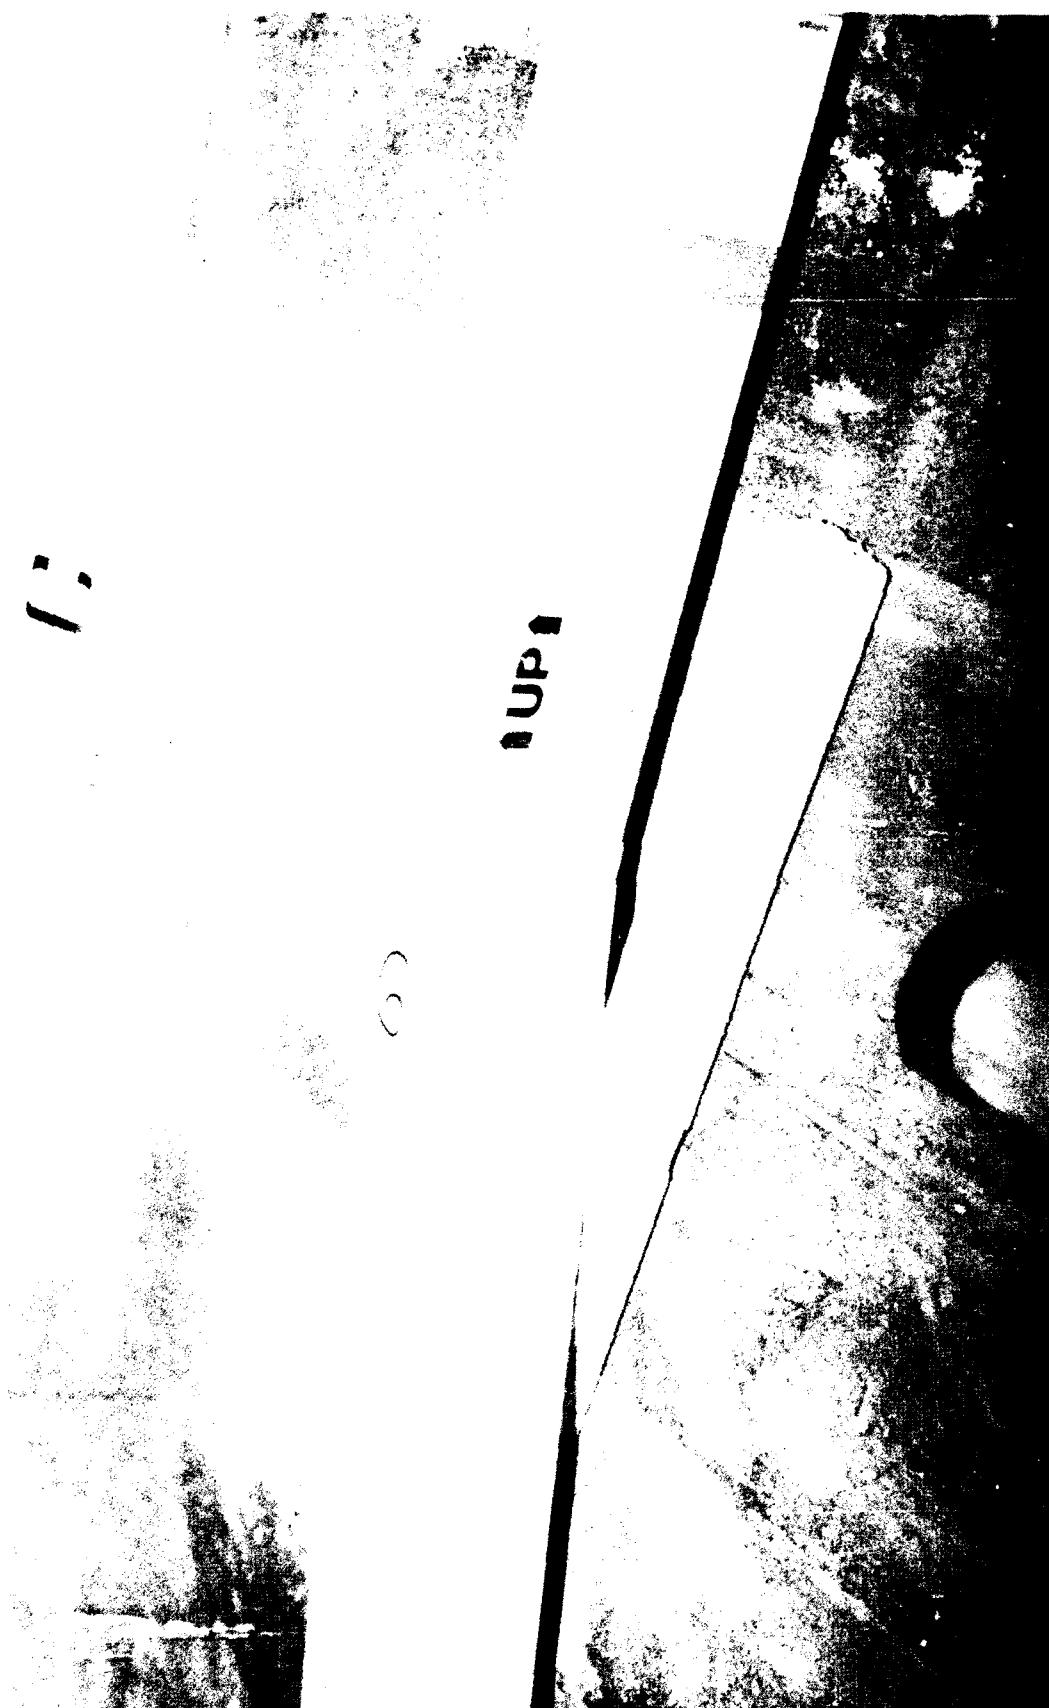
U.S. ARMY DEFENSE AMMUNITION CENTER AND SCHOOL - SAVANNA, IL
	Photo No. A0317-SPN-90-229-3037. This photo shows the original issue restraint beam, sample no. 6, after applying a point load.

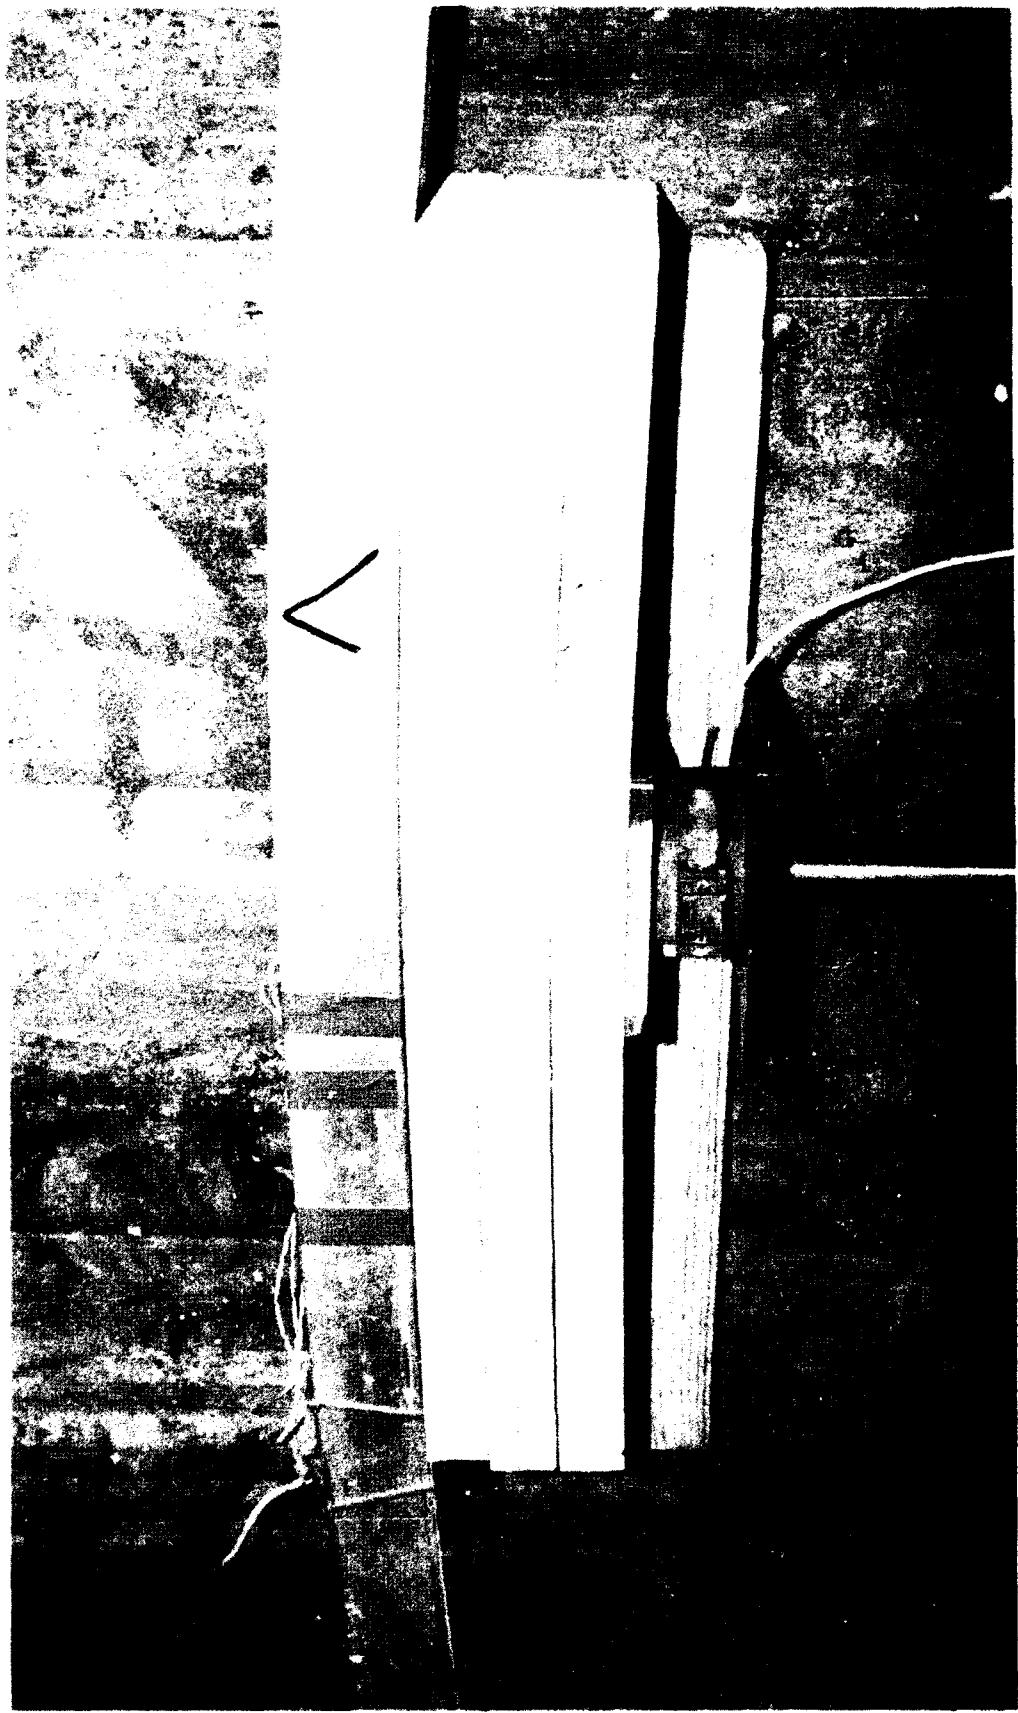
Photo No. A0317-SPN-90-229-3040. This photo shows the original issue restraint beam, sample no. 7, with a load applied.

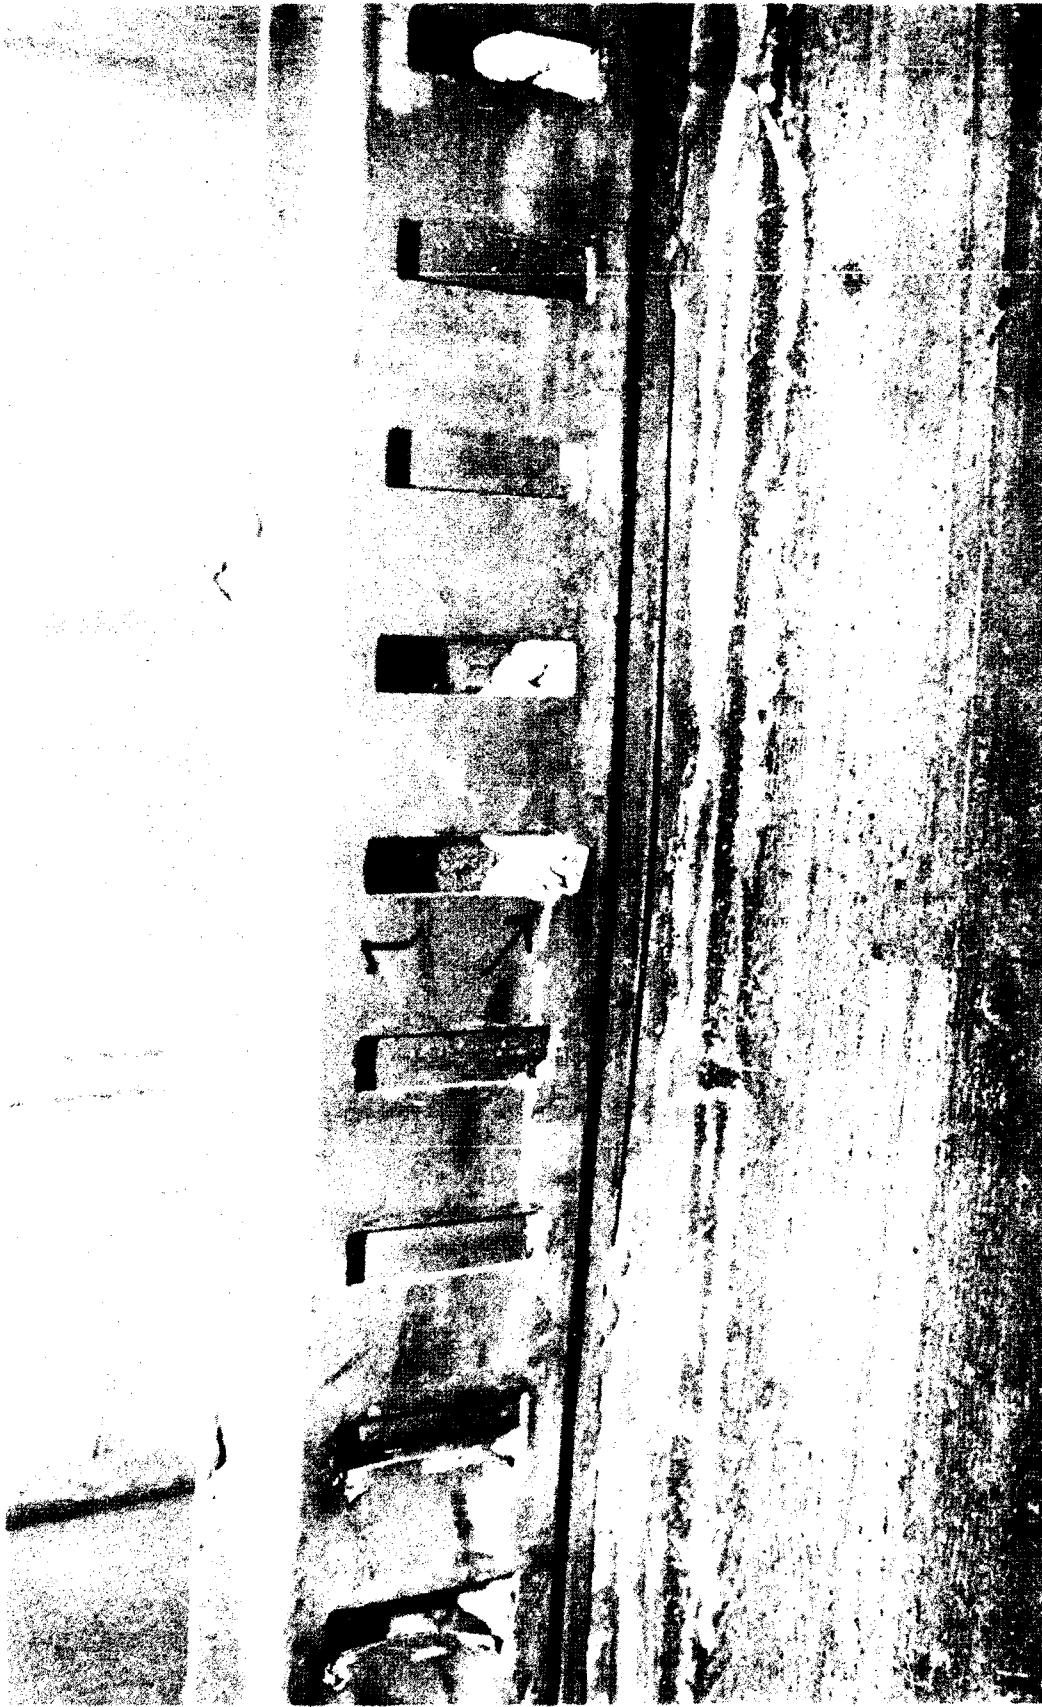
Photo No. A0317-SPN-90-229-3044. This photo shows the original issue restraint beam, sample no. 7, after the loading test. This photo shows where the restraint beam clamp disengaged from the belt rail.

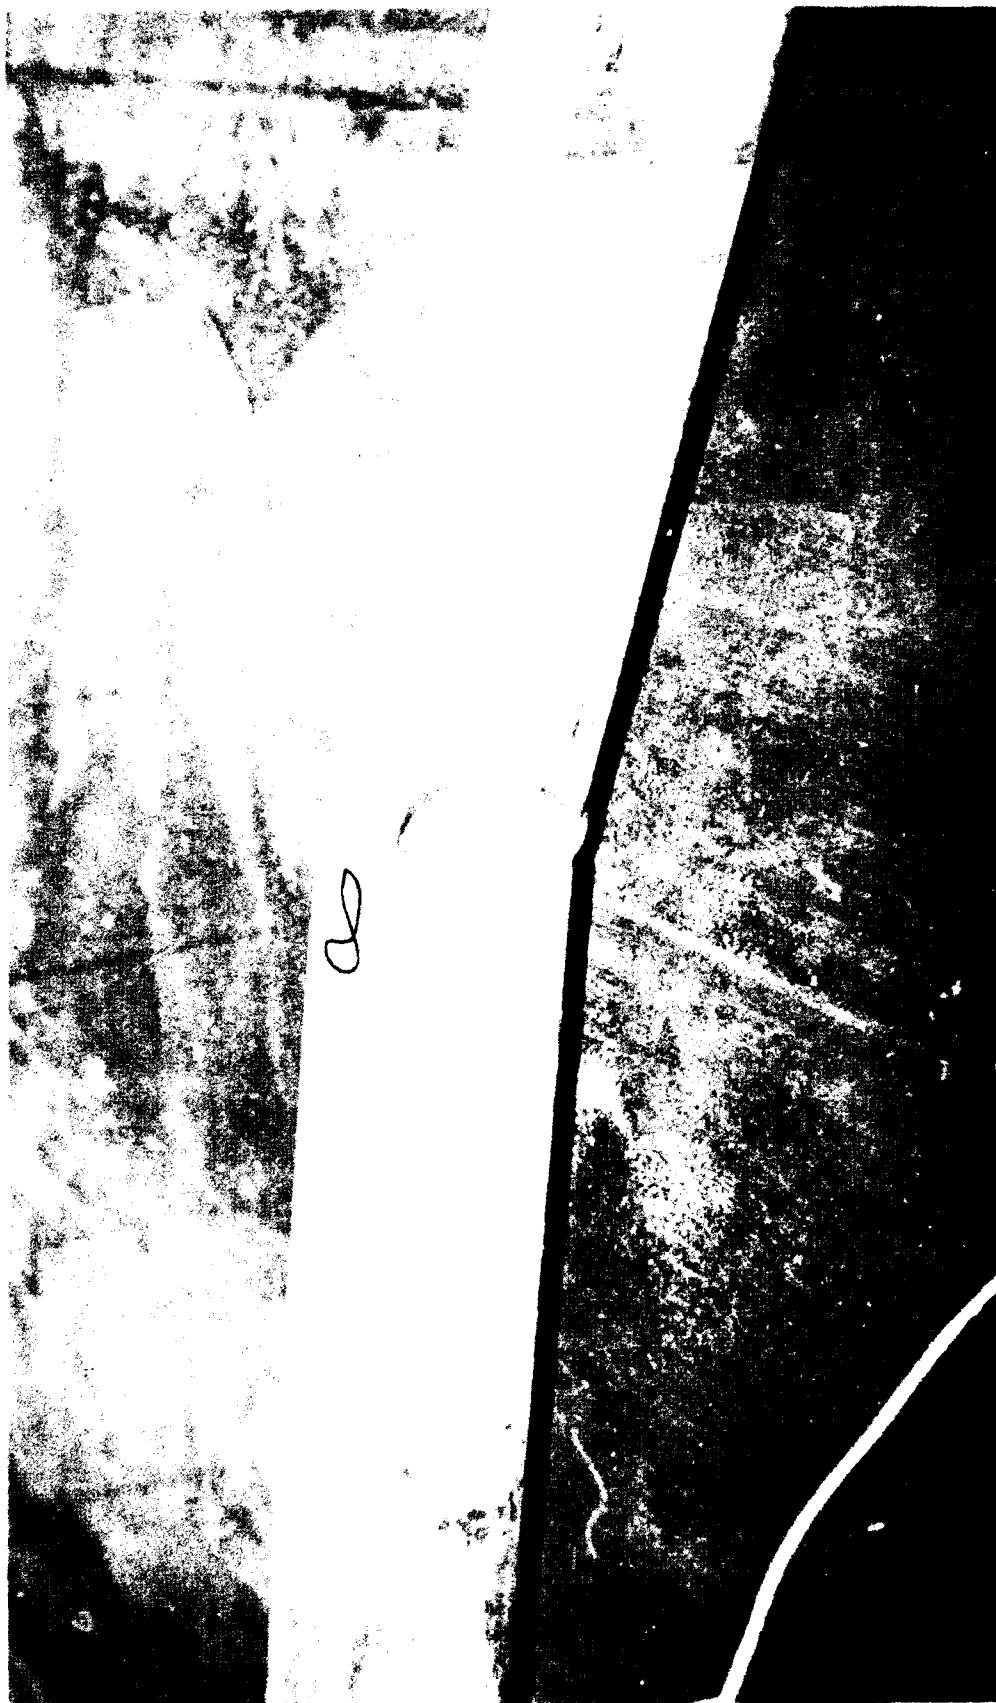
Photo No. A0317-SPN-90-229-3074. This photo shows the original issue restraint beam, sample no. 8, with a test load and resultant damage.

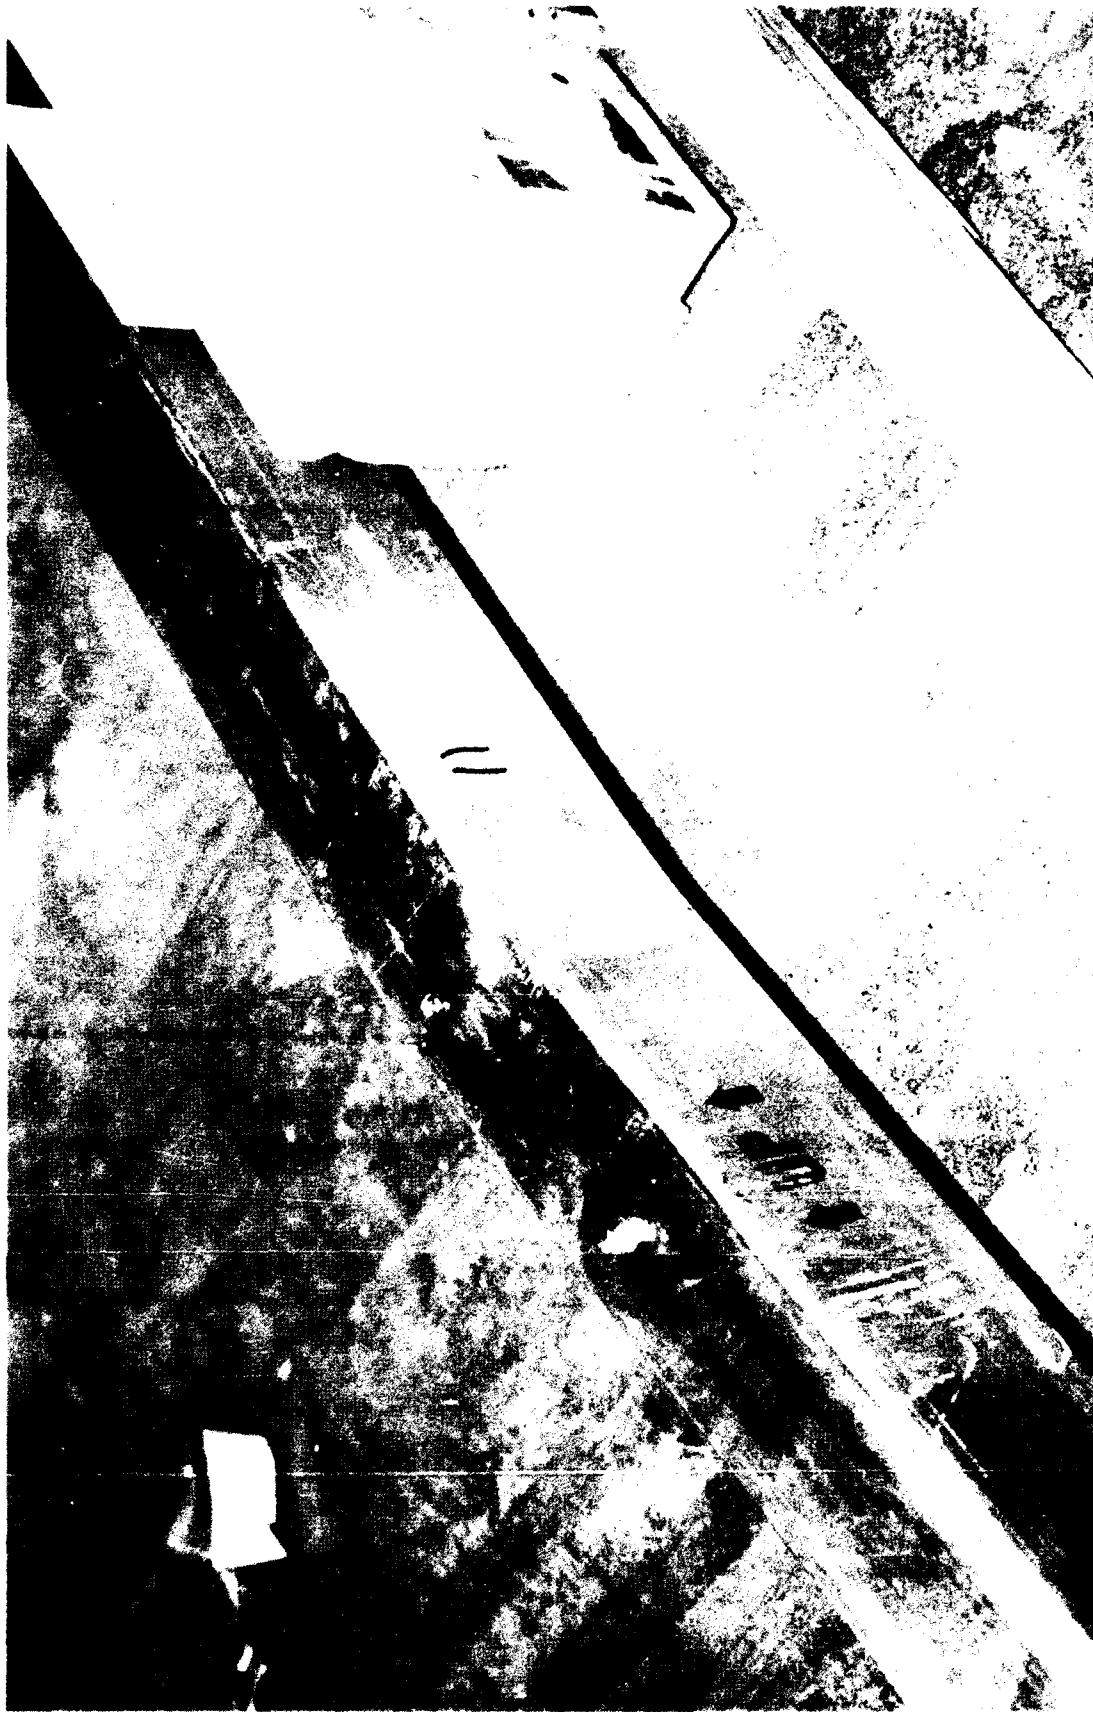
Photo No. A0317-SPN-90-229-3067. This photo shows test sample no. 11 after load testing.

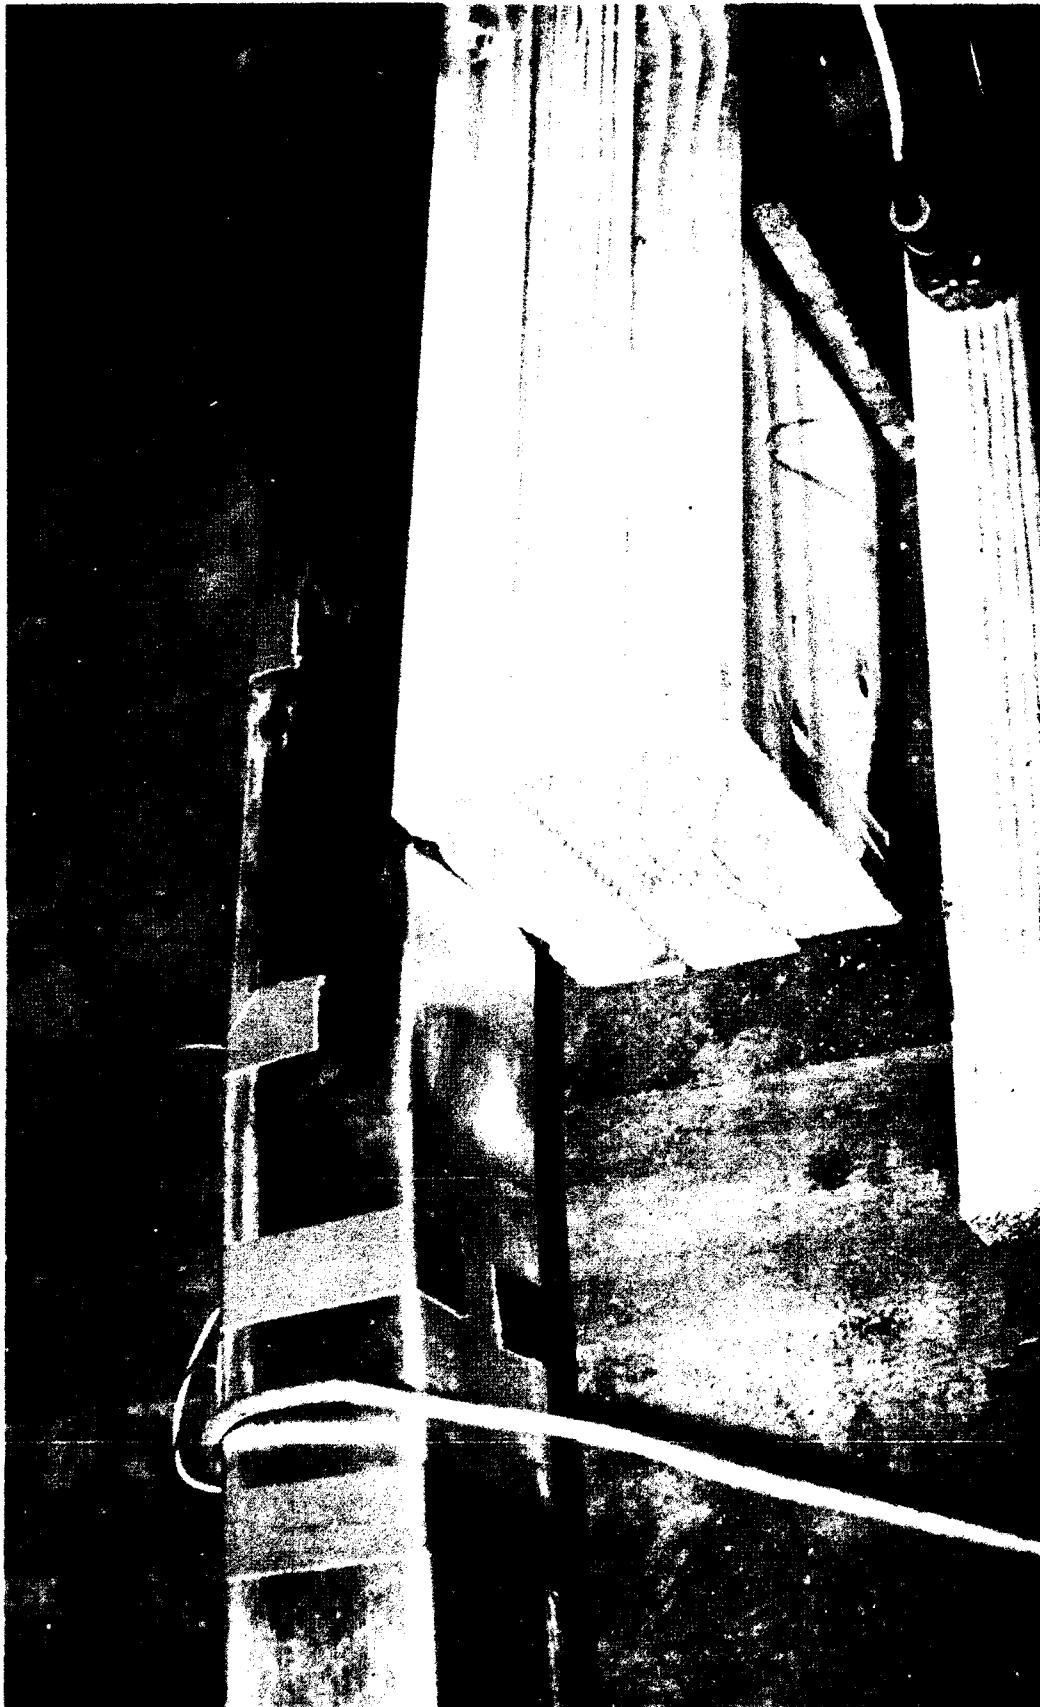
Photo No. A0317-SPN-90-229-3064. This photo shows test sample no. 12 after load testing. Note buckling damage perpendicular to the length of the beam.

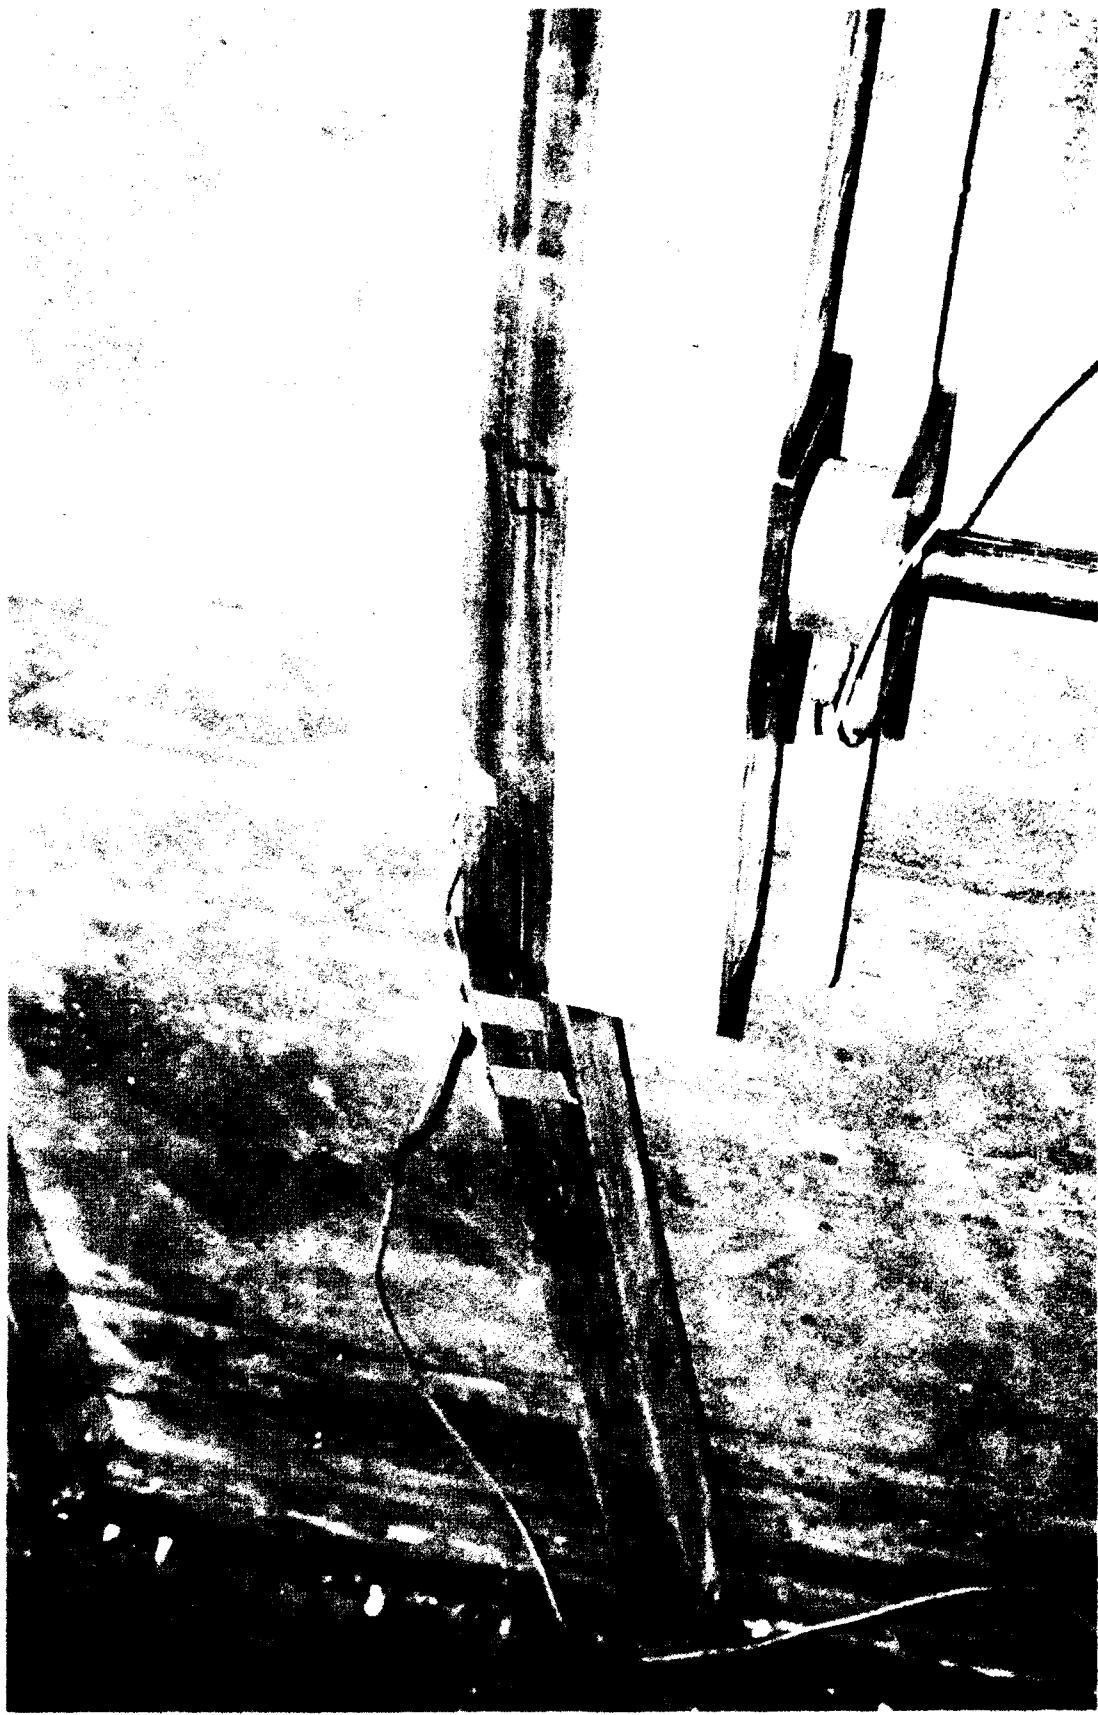
Photo No. A0317-SPN-90-229-3058. This photo shows test sample no. 13 fully loaded. Loading force on the beams increased to a repeated level before failure. After this point, additional load caused increased bending and beam set.
